Attachment 1 - Asset Condition Report

Bonnie Doon Recreation Reserve

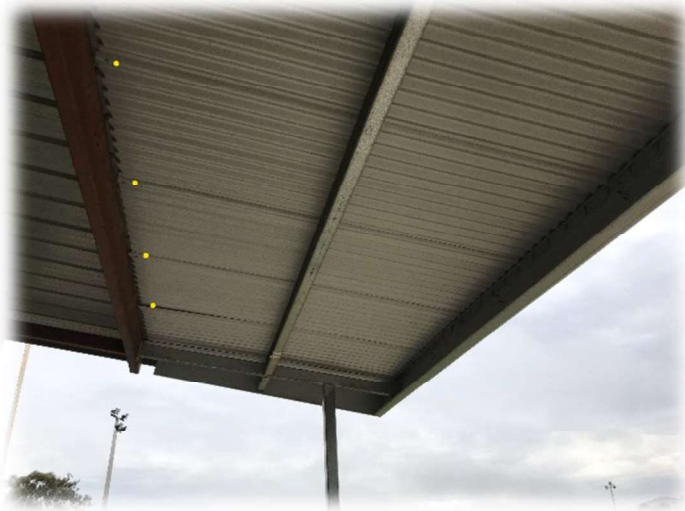
- The upper level balcony on the north side (overlooking the oval) was extended approximately 5 years ago. It requires an additional purlin support where it connects with the original awning to ensure it is safe to walk on.

- It currently has insufficient fixings in the roof sheets (depicted by yellow dots). The concrete floor of the awning has settlement cracks which have been sealed to prevent water entry and should be monitored for further signs of deterioration.

The underside of the main awning is open and unlined which provides perching points for birds. There is a health risk associated with the extent of bird droppings present. Bird droppings not captured in this photograph.

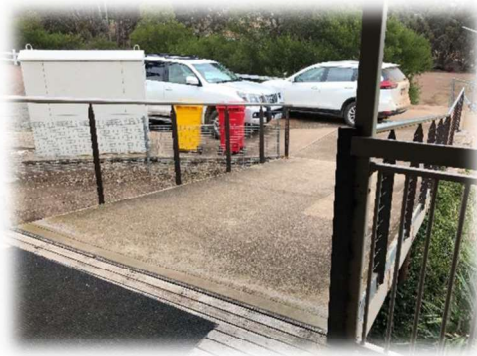
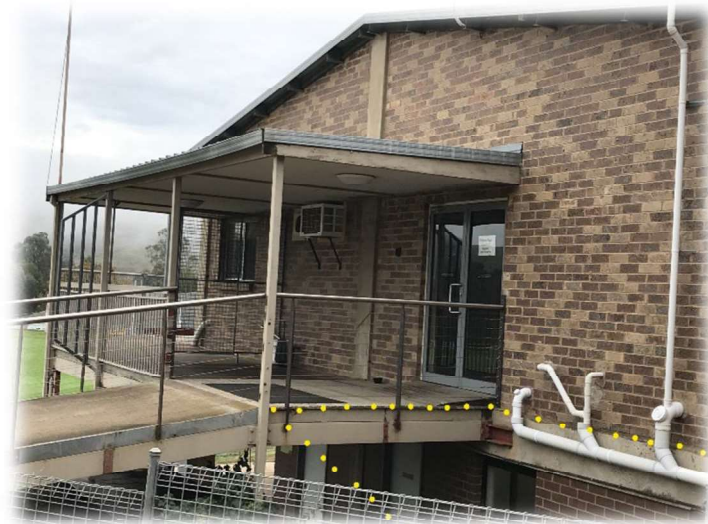
- **Main Entrance Ramp** 1st floor not DDA compliant. Incorrect gradient.

Proposed location to construct DDA compliant ramp entry. **Yellow** dots depict new suspended ramp.

- **DDA Compliant main entry:** Design and construct new compliant main entry suspended ramp to approach from the playground (South side)
- **Additional Men's Toilets:** There are currently only 2 men's toilets on the 1st floor of the building. If the building is used as a neighbourhood safe place it will be insufficient to meet demand. Investigate feasibility of constructing new accessible Men's toilets utilising existing Western Emergency exit door and building suspended room across void to southern side of building abutting existing under roof deck area. New hallway created to extend emergency exit.

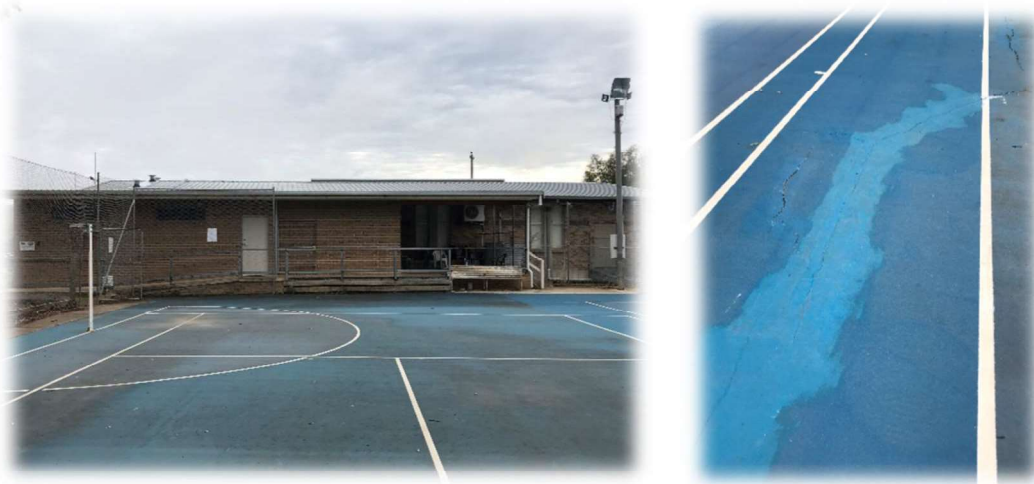
The 2 courts are constructed of a synthetic surface and are in poor condition with many existing and patched cracks in the playing surface. These would appear to be the result of unstable substrate.
