Mansfield Land Capability & Soil Assessments

LAND CAPABILITY ASSESSMENT

Report No. L41123

Client: Tony Roussos Site Address: 152 Davies Road, Merrijig

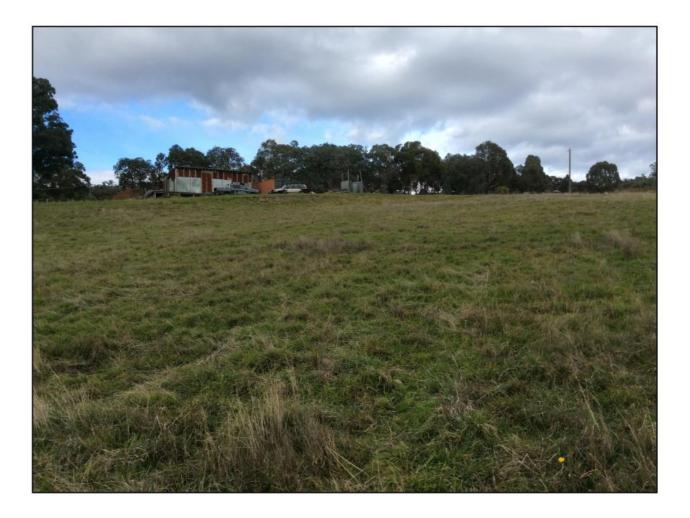
Figure 1: Proposed irrigation area viewed from north-north-west to south-south-east as on the 5th June 2023.

The subject allotment varies from undulating to hilly, majority of the property is greater than 15% slope. The proposed irrigation area (LAA) is located on undulating land approx. 25-35m north-north-west of the existing building and approx. 50m off the north-west boundary. The grounds slope varies between 10 and 17% predominantly in a north-north-west direction and is exposed to winds and sunshine throughout the year. Refer to figure 1.

The proposed irrigation area is vegetated with a mixture of pasture grasses including ryegrass and clover, as shown in Figure 1 and Appendix D.

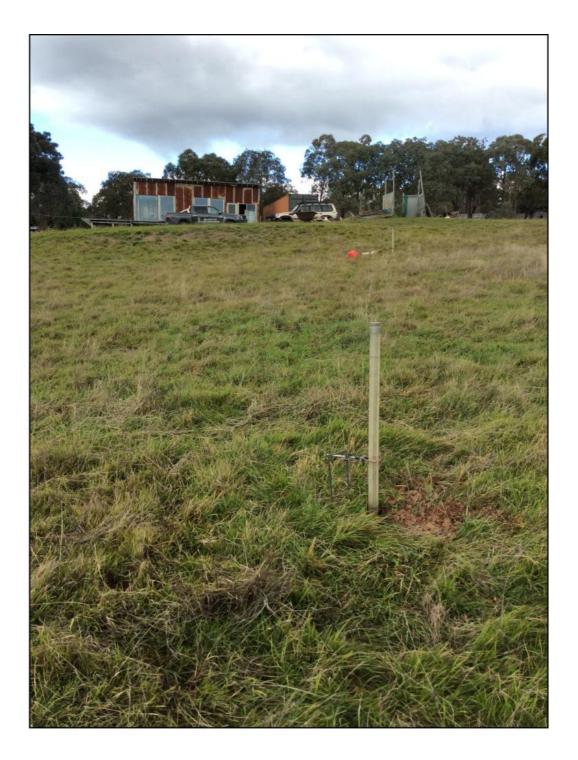
Appendix D

Photo of constant head permeameter tests conducted on the 5th of June 2023.

Soil permeability tests within the proposed irrigation area (LAA) were conducted using the constant head permeameter testing method in accordance with AS/NZS 1547:2012 as shown in Appendix D.

The soil profiling tests were conducted on the 5th of June 2023 as seen in Appendix E Constant head permeameter tests were undertaken and prepared in accordance with AS/NZS 1547:2012 as shown in Appendix D.

The constant head permeameter testing on the 5th of June 2023 resulted in a Ksat of .22m/day.

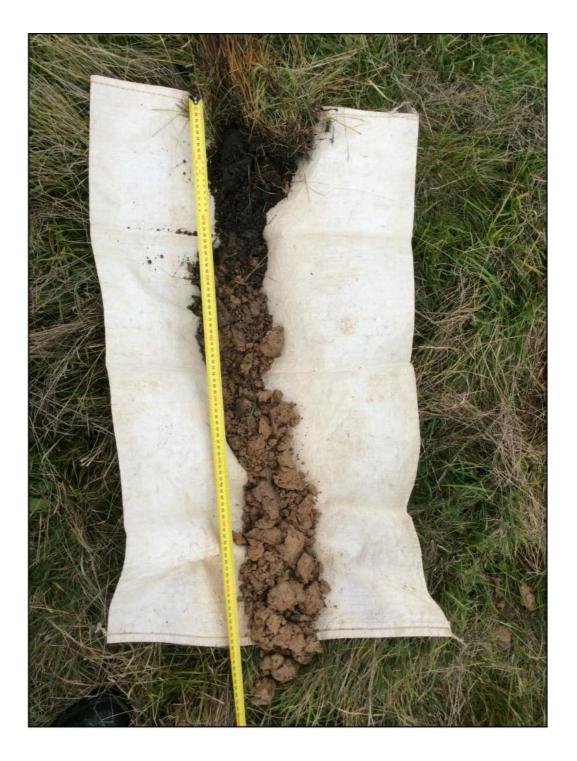
Appendix E

Soil Horizon

• A-horizon; layer of dark brown, sandy silt (loam), with a soil reaction trend of 5.92 pH and electrical conductivity of 0.23 dS/m, to a depth of 120mm

• B_1 -horizon; layer of brown, sandy silty clay (clay loam), with a soil reaction trend of 5.68 pH and electrical conductivity of 0.21 dS/m, between the depths of 120-410mm

• B_2 -horizon; layer of light orange-brown sandy silty clay (light clay), with a soil reaction trend of 5.53 pH and electrical conductivity of 0.20 dS/m, between the depths of 410-1000mm.

The soil horizon profile can be seen in Appendix E.

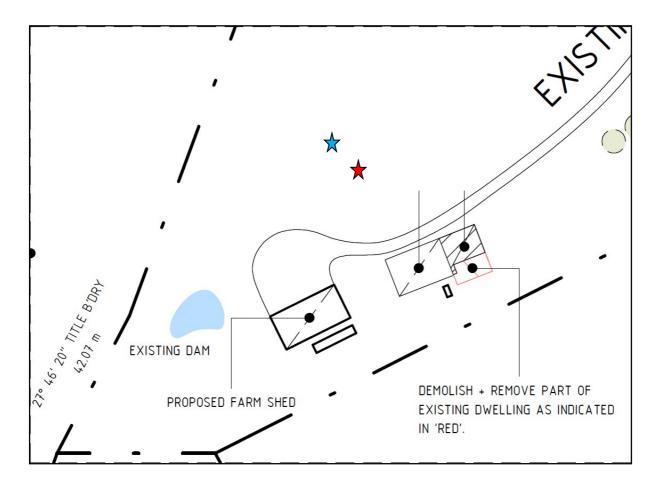
Bore hole testing location ★ Bore Hole 1 – 37.1346° S 146.2618° E ★ Bore Hole 2 – 37.1344° S 146.2618° E

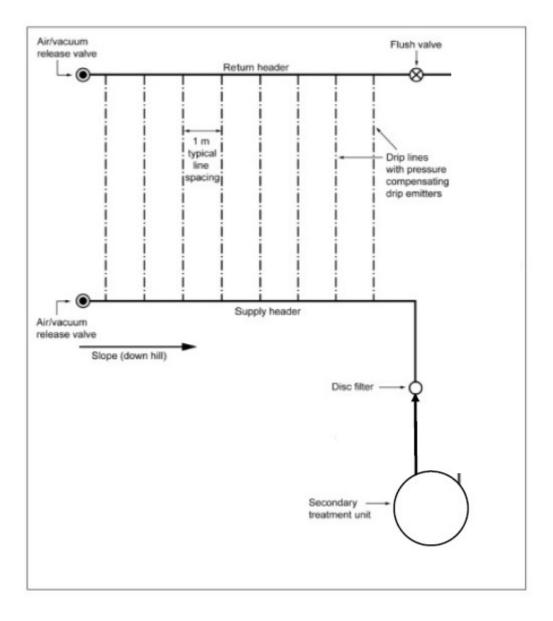
Drip Irrigation System

The effluent generated from the proposed dwelling will be black and grey water classed as 'all waste' and will be treated using an AWTS and pressure-compensating sub-surface drip irrigation system.
