Attachment 1 - Asset Condition Report

Bonnie Doon Recreation Reserve

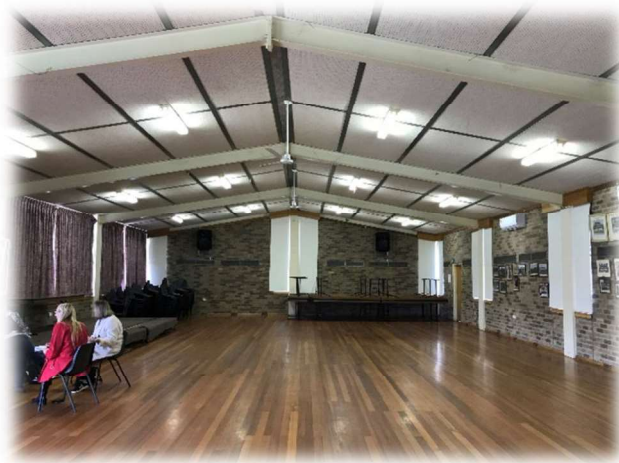
The building was originally an elevated double brick structure supported by a combination of concrete and steel columns on a suspended concrete slab. The upper level has the following existing features;

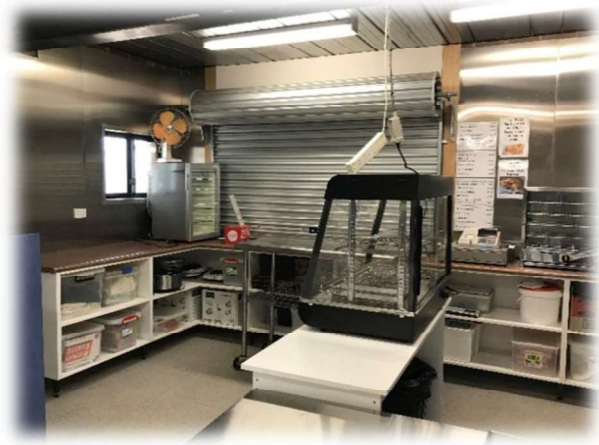
Over time the lower level has been progressively extended by the addition of brick walls between the existing columns to the open portions of the building at ground level. This has resulted in the original canteen being repurposed as a gymnasium space and visitors change room.

A new commercial kitchen / canteen and bar has been constructed within the extension, and additional public toilets and referee's change room have also been added

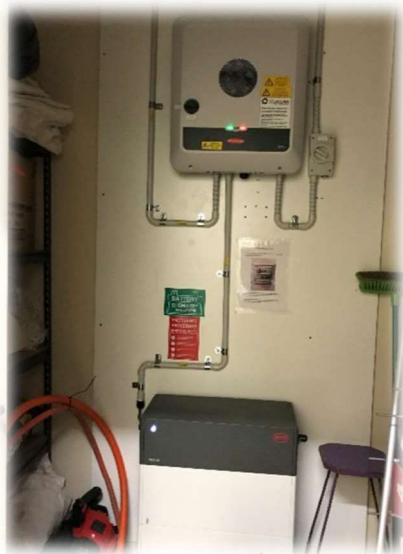
A roof top solar power system is installed on the building comprising 40 X 370W solar panels with a Fronius inverter and BYD storage battery. The system is designed to back up the lighting circuits in the event of a grid power outage.

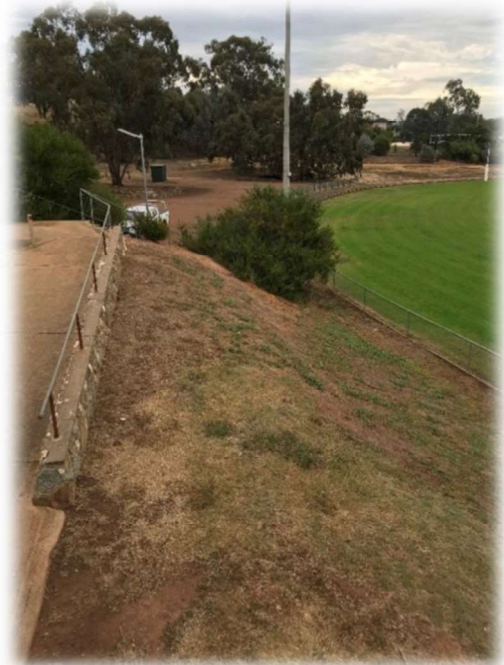
The football club have received a grant of \$20,000 for terracing and seating to the grassed hillside area.
